CENTRAL INTELLIGENCE AGENCY
INFORMATION REPORT

COUNTRY Czechoslovakia

SUBJECT Army Observation Posts

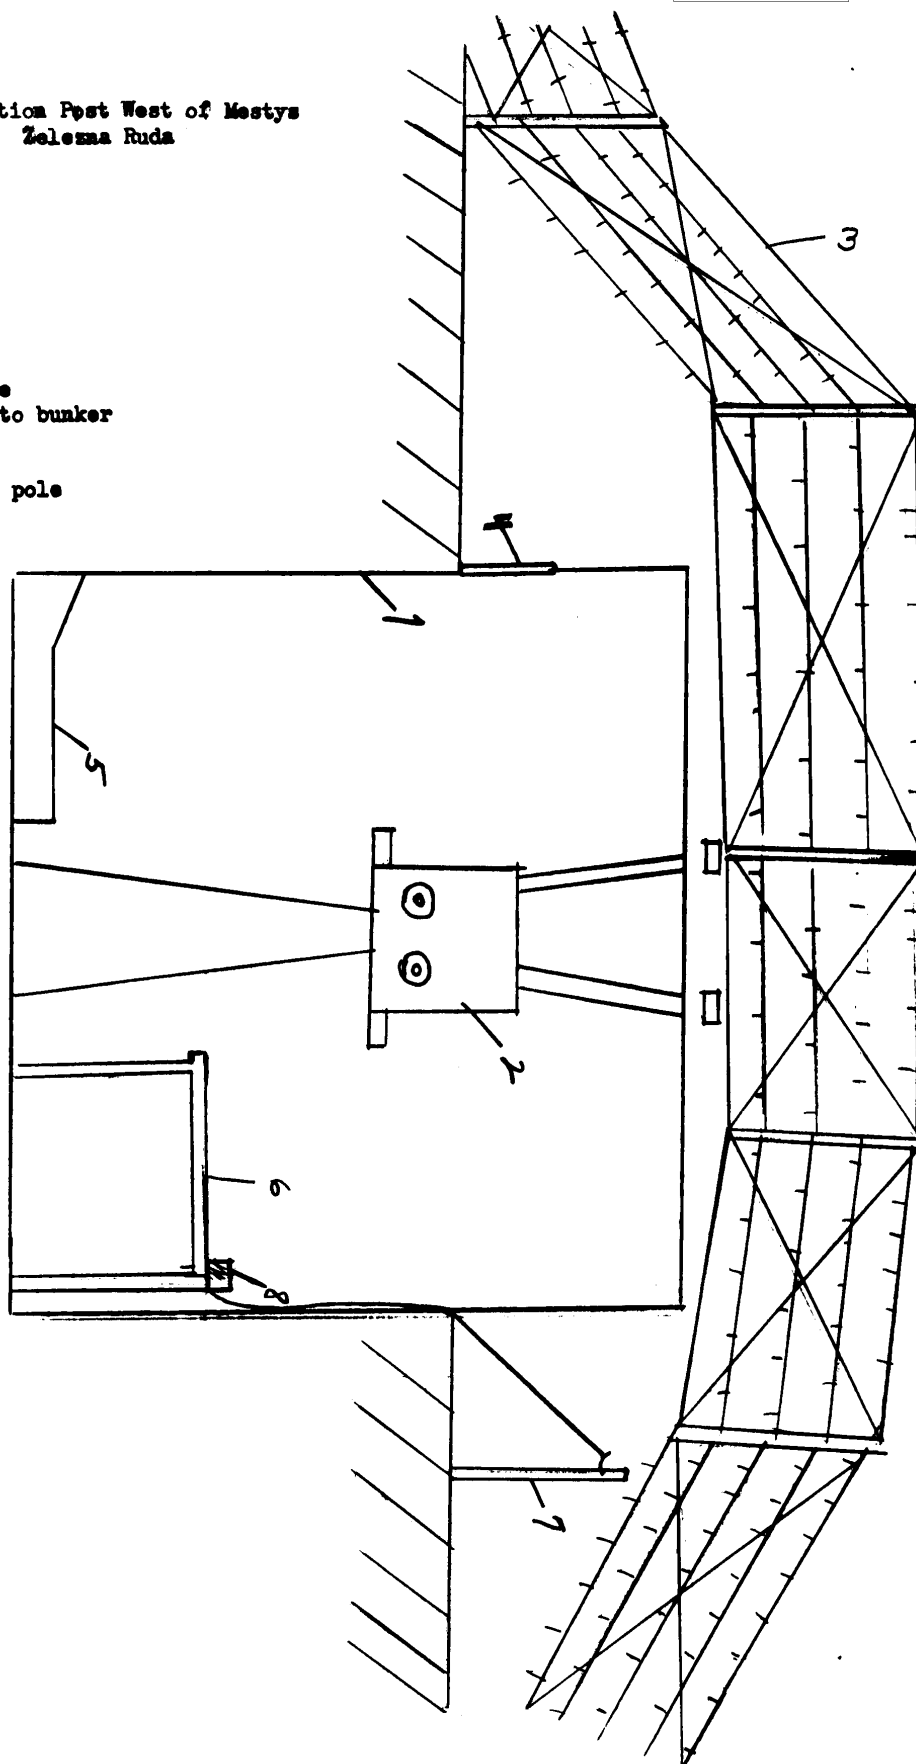
Observation Post West of Mastys
Zelezna Ruda

1. An observation post is located west of Mestys Zelezna Ruda (N 49-08, E 13-15), 900 meters north of Alzbetin, right on the edge of the woods. It is actually an under-ground bunker 6 x 4 meters in size, dug about 150 cm. into the ground and projecting about 100 cm. above the ground. It is made of wooden beams and covered with earth. There is a revolving periscope in the bunker, which is connected by telephone with 9th Company headquarters. On the north side of the bunker is a barbed-wire fence about 180 cm. high. Tin cans are hung on the fence. There is always a seven-man crew in the bunker. The crew's food supplies are delivered from the 2nd PS Company in Mestys Zelezna Ruda. One man from the crew is always on patrol around the bunker. 25X1

1. Bunker
2. Periscope
3. Wire fence
4. Entrance to bunker
5. Beds
6. Table
7. Telephone pole
8. Telephone

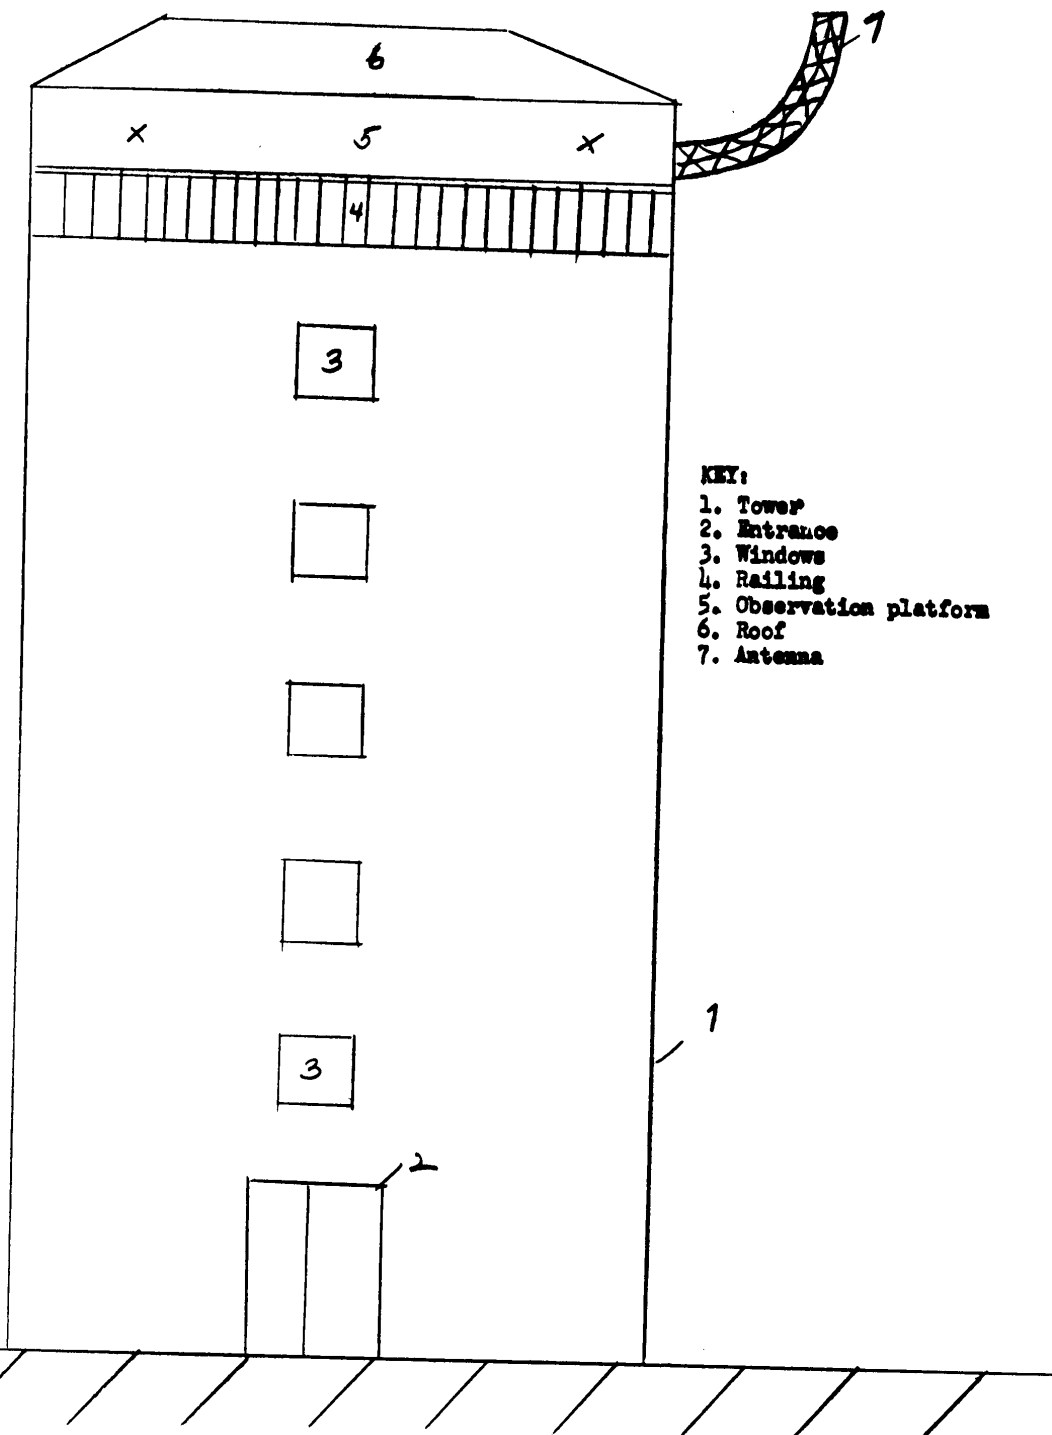
Observation post at Ryzmberk

2. An observation post is located in the tower of the ruins of the castle of Ryzmberk, which is in a woods about 1800 m. north-northwest of Kdnye (N 49-24, E 13-02). A country road leads from the ruins to Kdnye. The stone tower of the castle is about 40 m. high, square-shaped, with one side about six meters long. The tower has about 10 windows in front, one on each floor. On the top there is an observation platform about two meters wide, with a wooden railing. This platform goes completely around the tower. The tower has on its east side a metal projection consisting of four metal rods and interwoven wires, looking like a wire net. It is probably an antenna. The area for a radius of about 200 m. around the castle ruins is forbidden. A telephone line goes from the observation post along the road to the barracks in Kdnye. In the tower there is a detachment of eight soldiers, which is changed every day. The soldiers are from the artillery barracks in Kdnye.
